# Kurnell community update

1 June 2022

# Investigation – outline and introduction

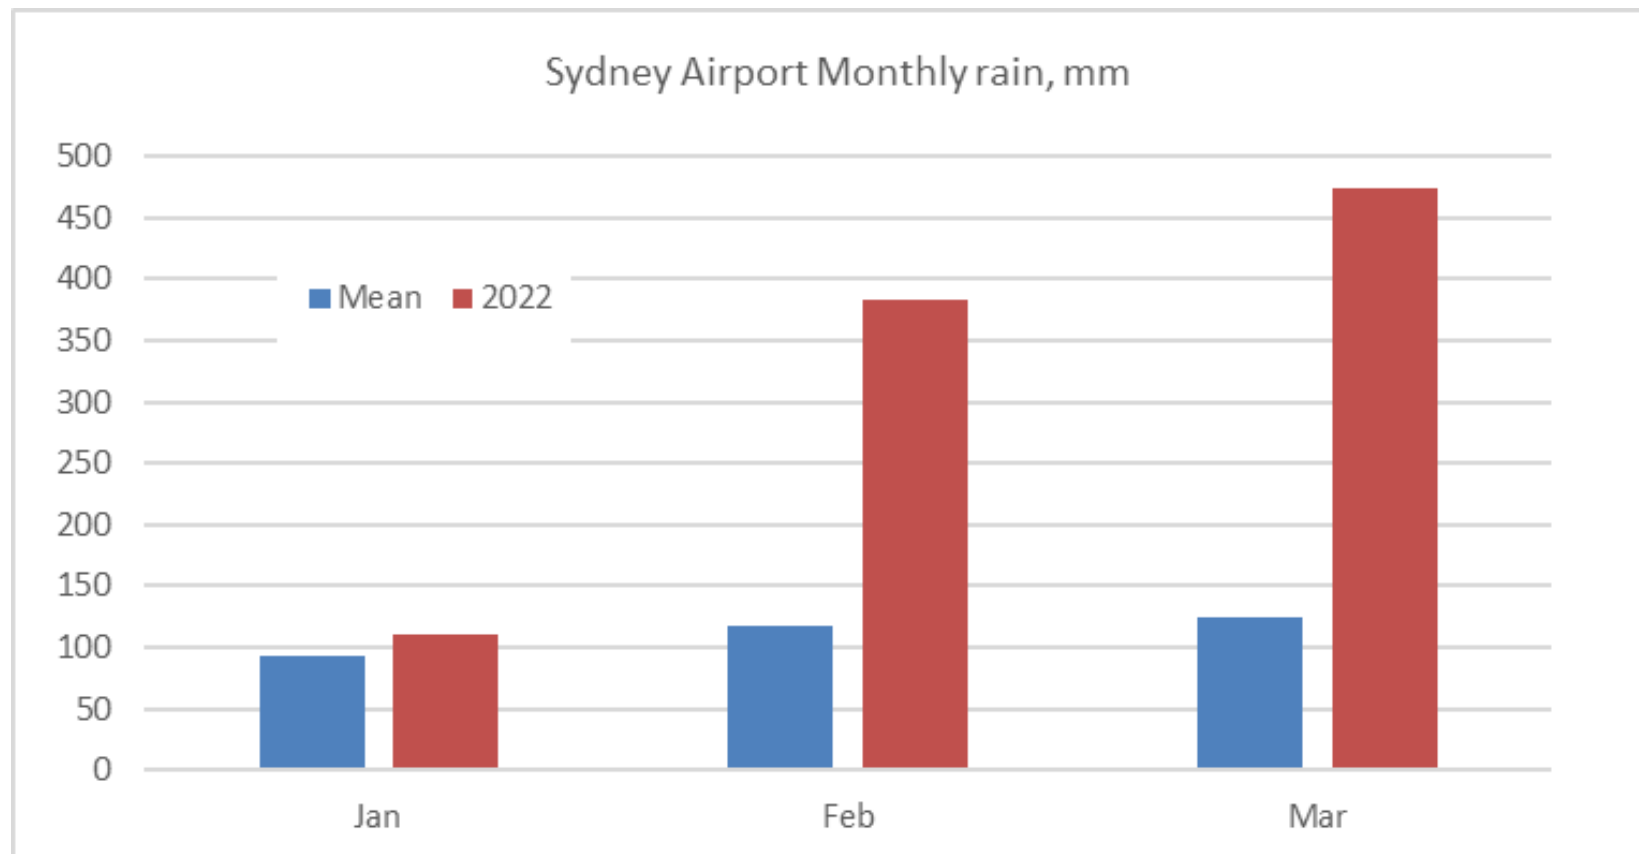
Rainfall at the start of 2022 well exceeded regular rain patterns. January-March 2022 received 968mm of rainfall compared to an historical mean of 336mm. This meant groundwater levels were high. Previous analysis shows that groundwater levels at Kurnell Terminal take approximately 4 weeks to return to pre-rain condition.

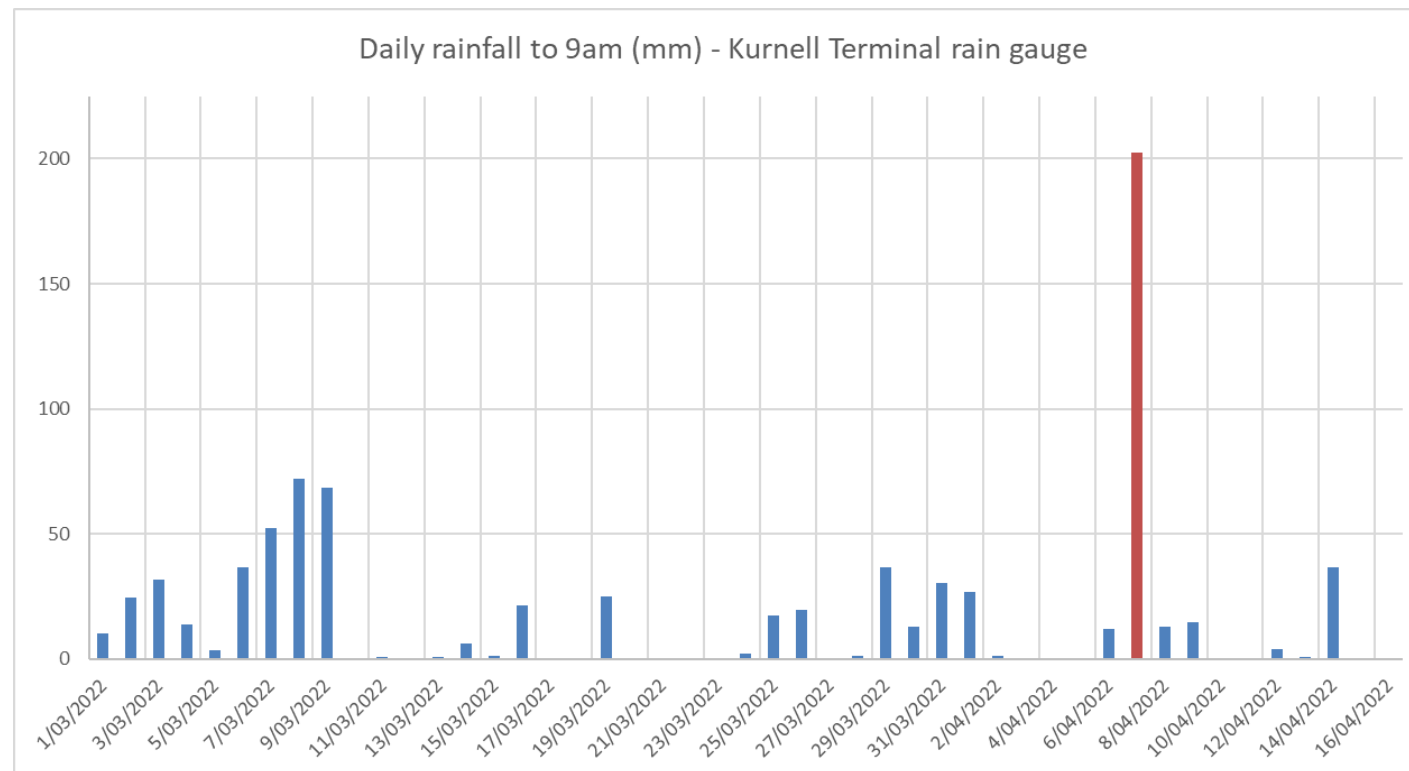
# Daily rainfall at the Kurnell terminal

Kurnell terminal received solid rain volumes from 1-9 March and then again from 25 March – 1 April. Rainfall in the morning and afternoon of 6 April 2022 (39mm between 12.01am to 7.00pm) provided fresh surface water.

At the time of major storm event (between 9.10pm on 6 April 2022 to 1:10am on 7 April 2022), groundwater levels would have been high.

Ground infiltration of stormwater in the catchment area during the storm event on 6-7 April would have been essentially zero, with close to 100% stormwater run-off.

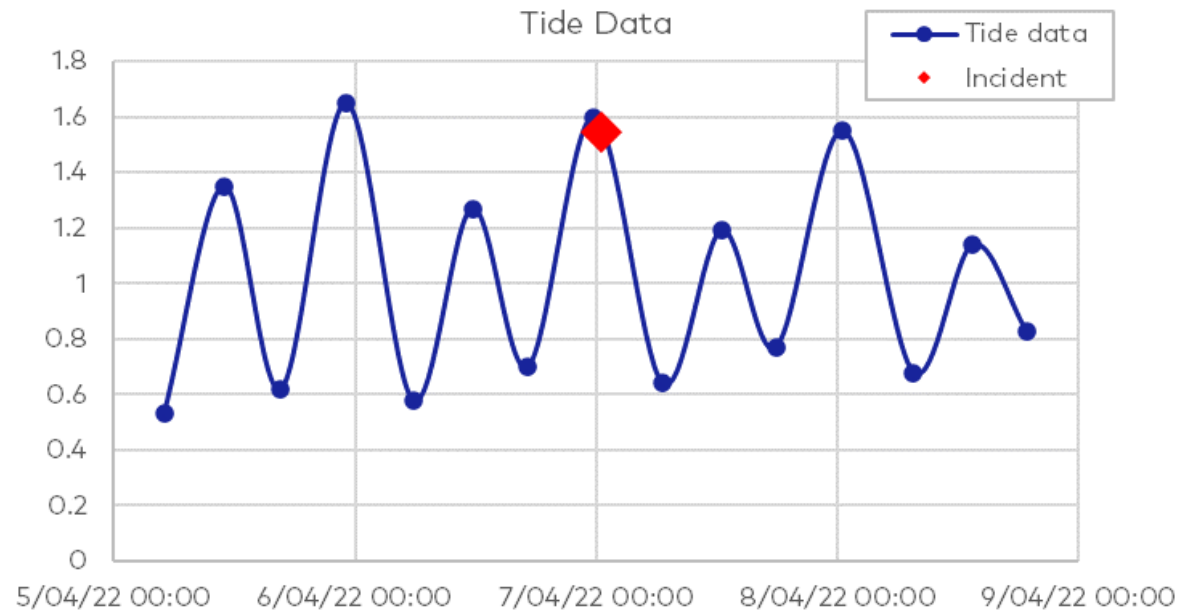
# Tide in Botany Bay

- Tidal data from Botany Bay is shown in the figure below, with peak high tide of 1.60 metres on 6 April 2022 at 11:46pm
- The peak high tide coincided with the timing of the storm event at Kurnell. The stormwater discharge from the Ampol Terminal Catchment B drains to Quibray Bay wetlands, which contain a tidal water level
- The coincidental high tide and stormwater run-off would have exacerbated the stormwater accumulation and flooding at the Kurnell Terminal wastewater treatment plant
