Kurnell overflow incident response 7th April 2022 – Results of the initial sampling round

Ampol Kurnell Terminal – Flooding Incident Emergency Response

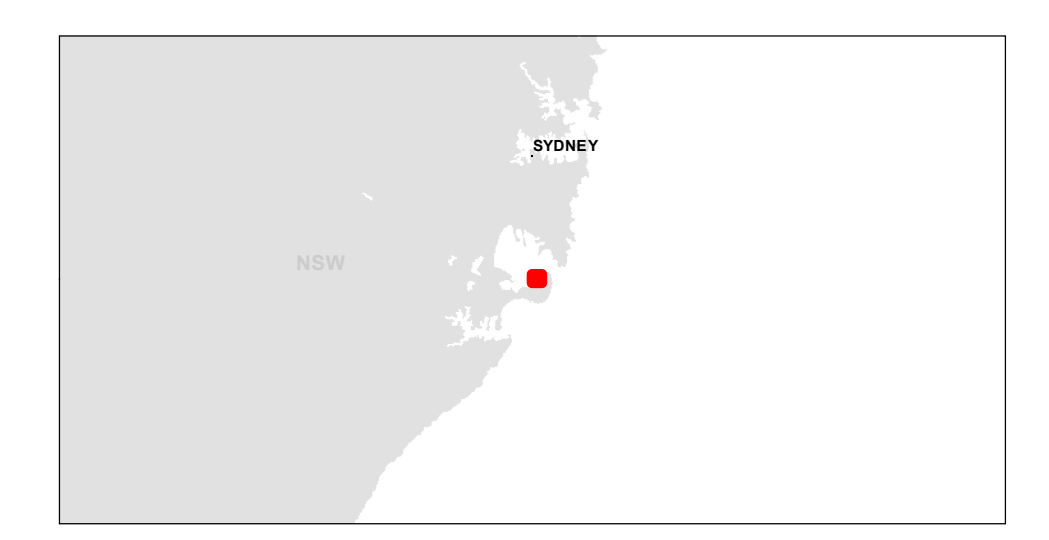
Estimated Initial Impact Area
